# Colmac Cx-Series Heat Pump Water Heating System: Jackson Apartments, Seattle WA

February 2022

Adria Banks, Colin Grist, Evan Green, Jon Heller

Ecotope Inc.

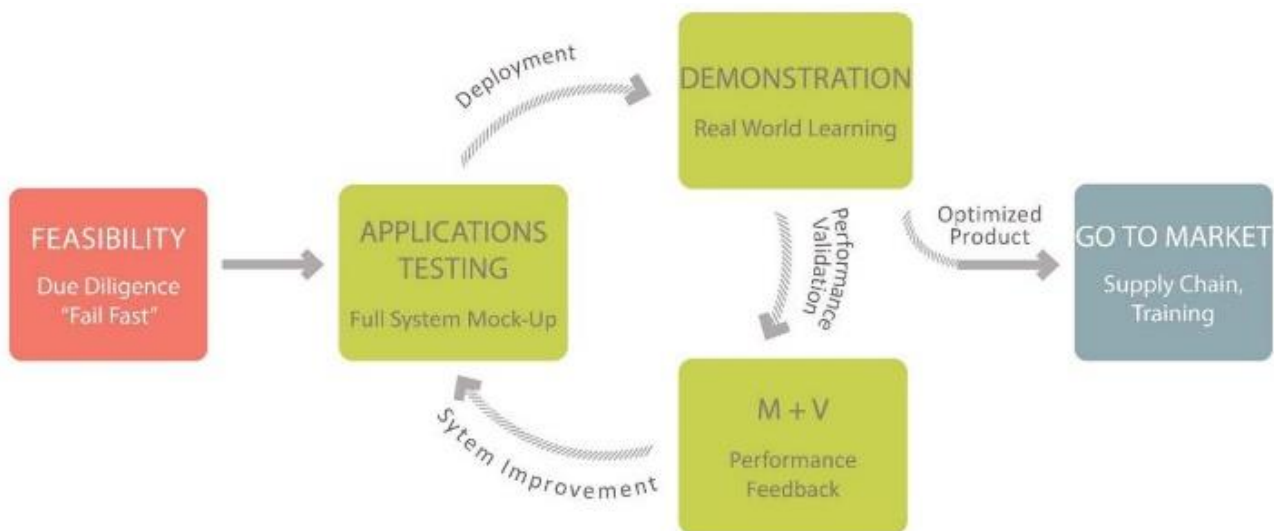
**Figure 1. Technology Innovation Model with feedback loop for further product development**

*The demonstration project at Jackson Apartments represents the latest product technology developments of Colmac’s HPWH equipment with integrated third-party controls, based on improvements identified through the TIM.*

operation controls, and creation of a ‘packaged’ product to reduce the need for tailored engineering for each installation and to allow broader implementation of the technology. A “version 3” design was installed at Batik Apartments, a seven-story, 195-unit mixed-use building in Seattle, WA (which was also included in the persistence study). That project implemented many design refinements and minimal controls. A similar system was installed at Cypress Apartments, a nearby building with over 200 units and street-level retail. The Cypress project used similar design criteria as Batik, had improved controls (with logging capability and data collection on tank

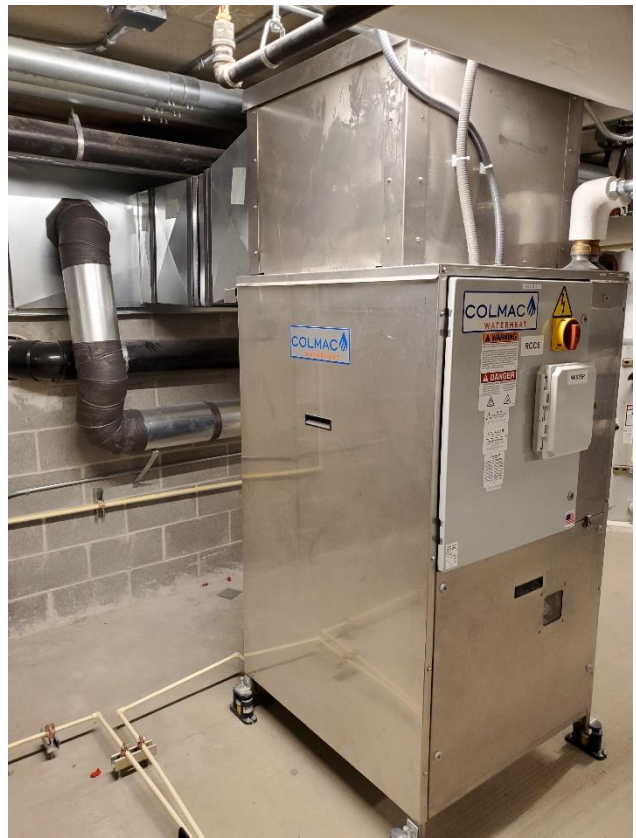
**Figure 4. HPWH-5, one of two primary CxA HPWHs**

This report covers only the design and monitoring of the East plant, which serves 166 apartments. The primary water heating is accomplished by two CxA units (HPWH-5

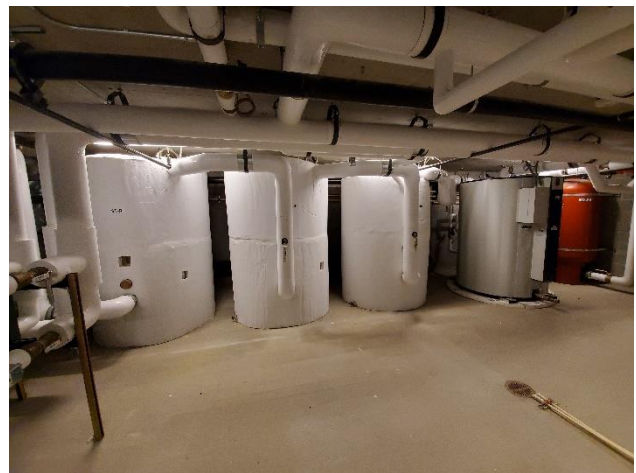
**Figure 5. Left to right - primary storage tanks ST8-10 and WH-3 (trim tank)**

The aim of primary storage tanks in series is to create a stratified volume of water such that the water closest to delivery to the building is warmest, and the water closest to the HPWHs is coolest. We can see that stratification in Figure 15. The outlier values for ST-8 and ST-9 occurred in mid-February

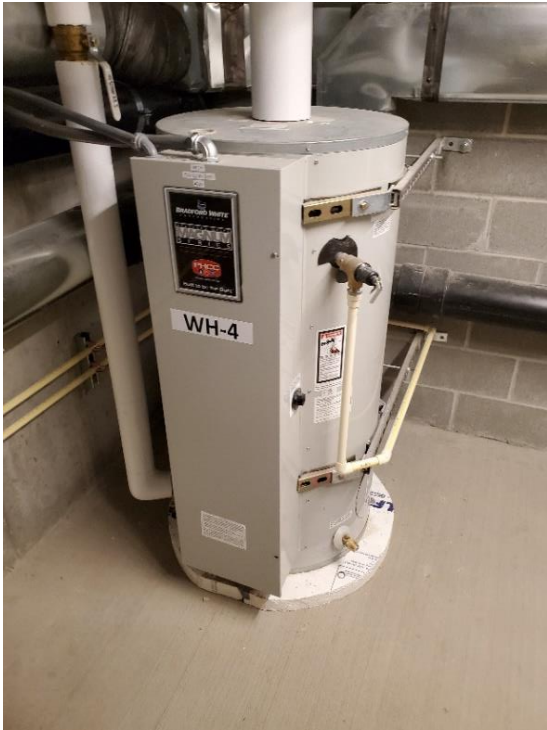
**Figure 6. Backup primary electric resistance tank, WH-4**

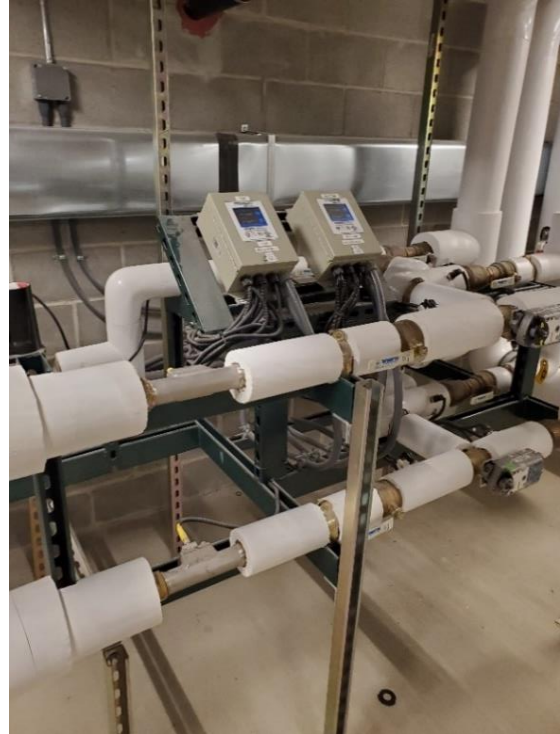
**Figure 8. BAS-enabled digital mixing station, yellow thermistor visible in left front pipe**

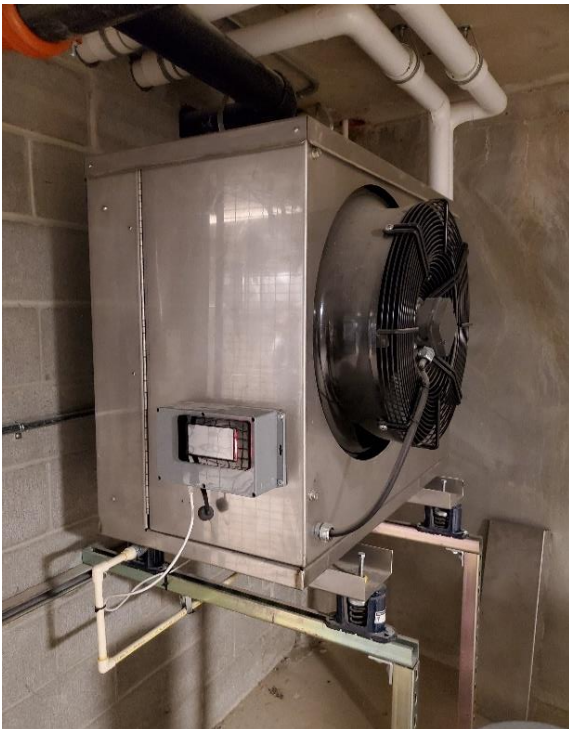
**Figure 7. Wall-mounted temperature maintenance HPWH-7 (CxV)**

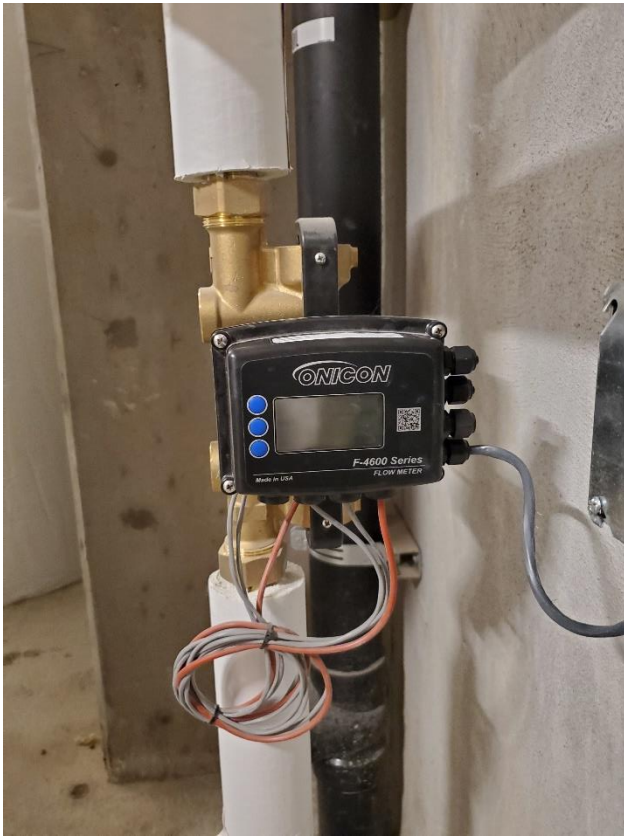
**Figure 10. Ultrasonic flow meter**

the flow meter still in alarm. Following our site visit, a technical assistance case was opened with Onicon, the flow meter manufacturer, and an Onicon representative scheduled to make a site visit. Review of the power and installation appeared normal, but intermittent no flow, reverse flow, and output alarms continued on the display, while diagnostic information and the sensors seemed to be working. After further consult, Onicon technical support suggested trying something that had worked recently at a different project. There they had found electrical noise being conducted through the copper pipes; this noise was just enough to cause the processor to incorrectly read the sensors in the meter. A ground wire from the meter body to a ground input on the circuit card was added to the Jackson flow meter and

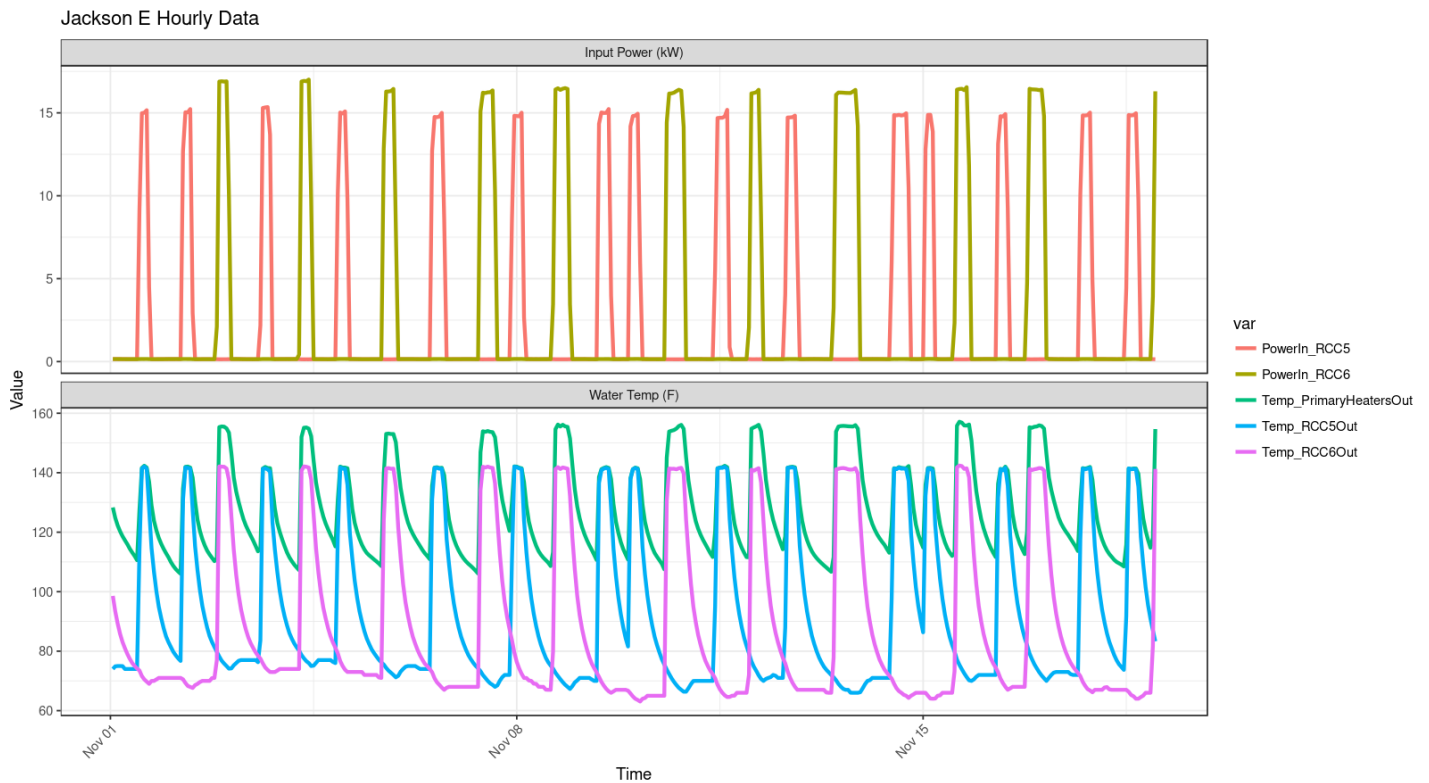
**Figure 11. Fall 2020 data showing different exiting temperatures and power readings when individual HPWHs were engaged**

Other anomalous readings were observed in the primary heating loop, in the temperature, power, and flow readings. Access to the temperature readings in the HPWH units themselves was available via the control points, and M&V monitoring added separate thermistors to the pipes routing water into and out of the primary heaters. While the thermistors in the HPWH showed similar exiting water temperatures (~141°F) during heating calls, the M&V temperature sensor showed elevated temperatures (>150°F) only when HPWH-6 was running. There were similar trends with different flow and power readings depending on which HPWH was running (see Figure 11). The project team suggested that the thermistor in HPWH-6 could be giving an artificially low reading, and Johnson Barrow verified conditions on-site. It was found that the HPWH-6 thermistor was loose in the thermowell. Thermal paste was applied, and the probe was properly secured in March 2021. This resolved the temperature and power disparities between the two units; however, the flow readings were unresolved.

In March 2021, both HPWHs were frequently staging simultaneously to meet the load. During short periods, individual HPWHs would be engaged and the flow disparity between the two units continued. Additionally, flow readings simply seemed too high. In April 2021, the project team further examined the flow meter installation and found that the meter was in alarm and confirmed that the readings were not coinciding with the in-unit flow calculated by the primary HPWHs. It was determined that the meter had been installed incorrectly, and needed to be rotated 45°, so that the sensor port was located on top of the horizontal pipe. The plumber was able to make a site visit and rotate the meter in mid-July 2021. The flow disparity continued, and the project team made a follow-up visit the following week, finding

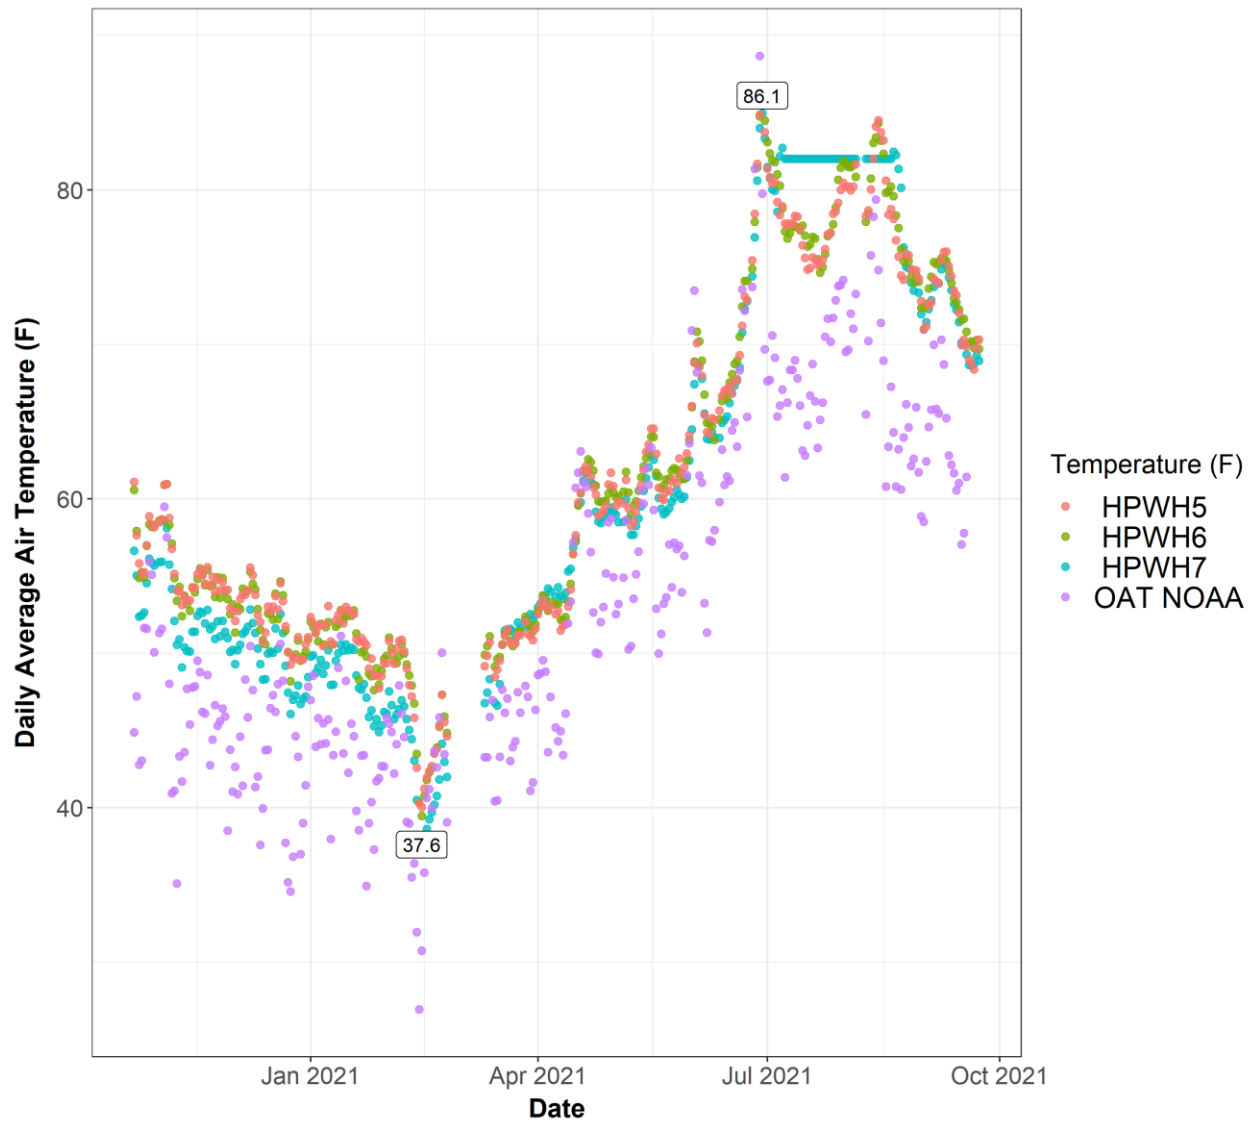
**Figure 12. Average daily incoming air temperatures at HPWHs installed in a parking garage with average outside air temperature**

This HPWH system was monitored for just under a year and operated under several extreme weather events in 2021. Even in the buffered conditions of a subterranean garage, these events are obvious in Figure 12 which shows the incoming air temperatures for each of the three HPWHs at Jackson Apartments alongside the outside air temperature from a nearby National Oceanic and Atmospheric Administration (NOAA) weather station. Beyond the temperature extremes, the air inside the garage is typically warmer than environmental conditions outside the garage. This has been reported previously at other subterranean garage HPWH installations<sup>iii</sup>. At this site, the air inside the garage was typically 5.5°F warmer than outside.

Both of these occurrences correspond to extreme weather events, which influenced city mains water temperature and the ambient temperatures in the garage (visible in the daily air temperature averages - Figure 12).

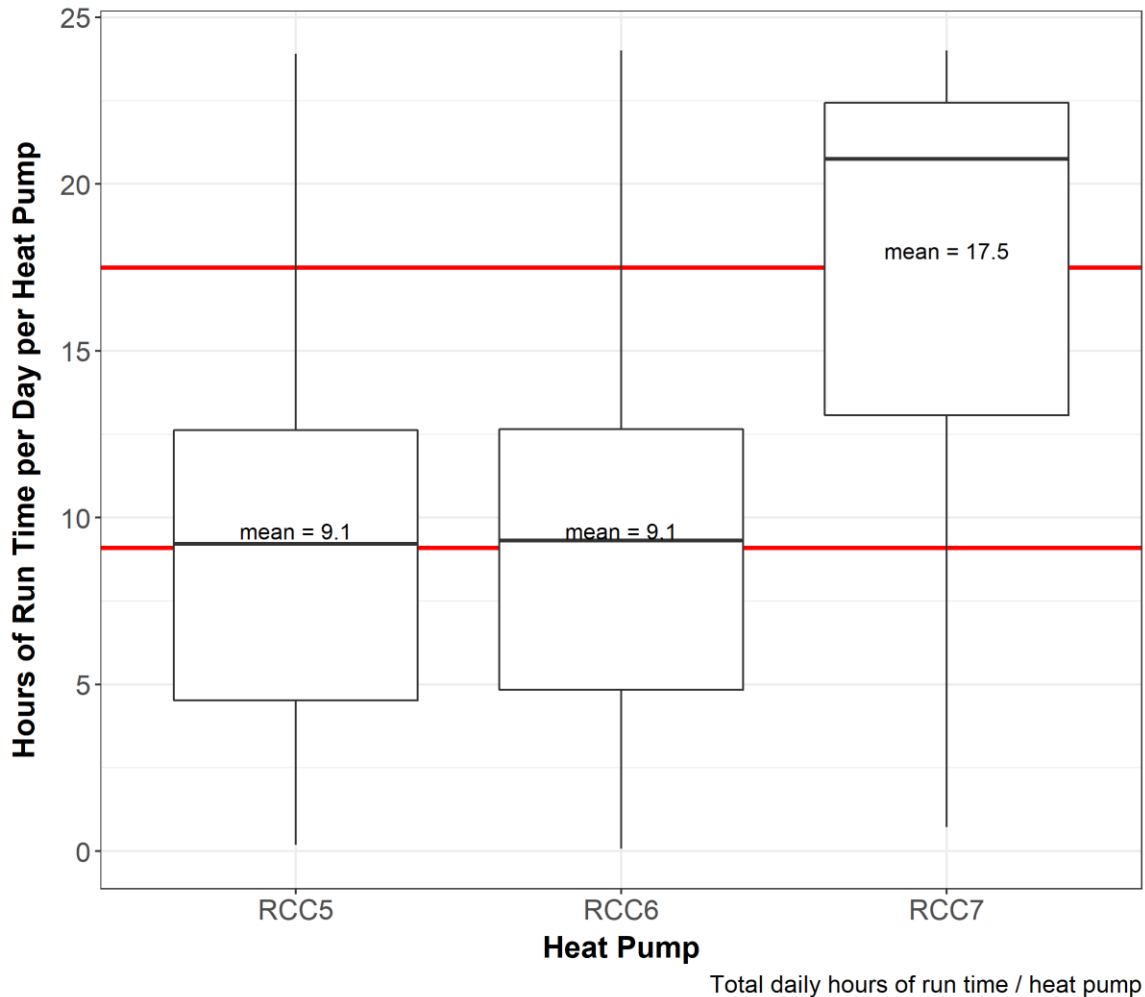
**Figure 16. Duty cycle of each HPWH overall averages shown as red lines**

Manufacturer guidance recommends that HPWH designs aim for the equipment to operate with a 16-hour duty cycle, or cumulative hours of operation per day. This balances equipment wear-and-tear with the possibility of a moderate capacity buffer for peak conditions. Figure 16 shows the duty cycle for each of the primary HPWHs (HPWH-5 and -6) and the temperature maintenance HPWH-7.

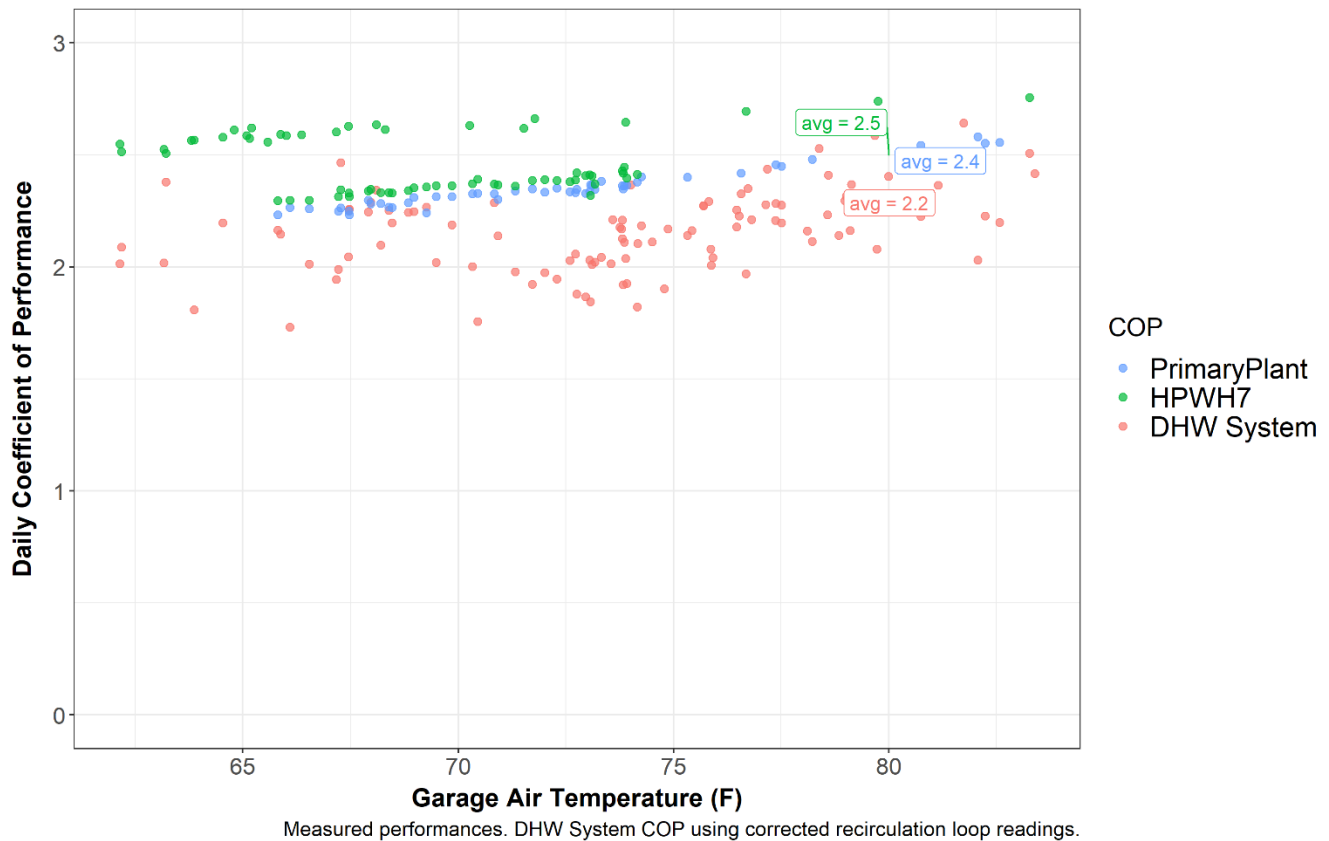
**Figure 18. Coefficient of performance for HPWH-7, the Primary Heaters, and the DHW system.**

Analysis was constrained to the period when the building had reached > 75% occupancy (June 1, 2021) until the end of the study period. Figure 18 shows the calculated performances from June 1, 2021, until Sept 30, 2021.

The CxA (Primary Heaters) and CxV (HPWH-7/Temperature Maintenance) equipment performed similarly to HPA equipment, where previous studies<sup>ix,x</sup> found average equipment COPs of 2.4 to 3.0. System COP at the study site for the June 1 to Sept 30 period was 2.2.
