Phase 3 – HID Persistence Testing

Final report: August 14, 2015

A Report of BPA Energy Efficiency's Emerging Technologies Initiative

The Lighting Research Center, Rensselaer Polytechnic Institute
21 Union Street
Troy, NY 12180

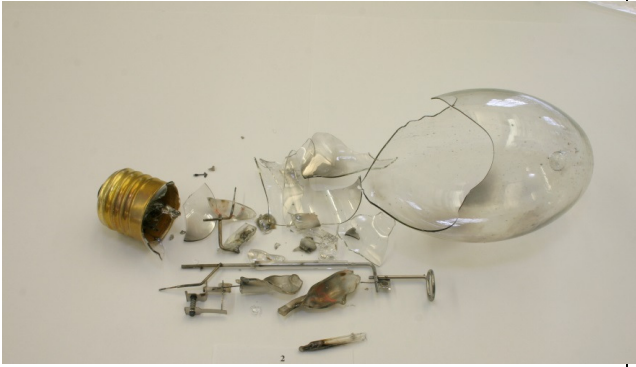
Lamp photo and failure mechanism	Lamp close-up
<p data-bbox="235 262 750 331">Lamp 2 (non-protected): outer envelope rupture</p>

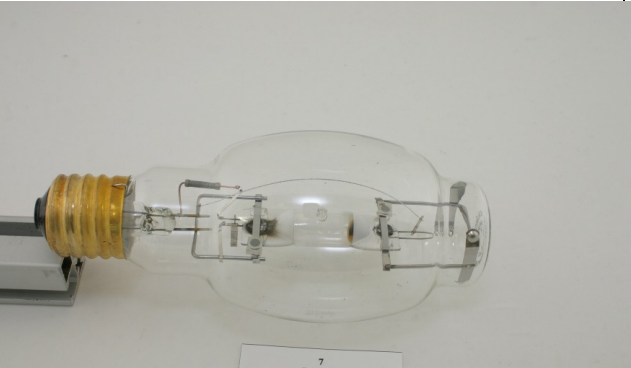
Lamp photo and failure mechanism	Lamp close-up
<p data-bbox="284 289 701 321">Lamp 7 (non-protected): flashed</p>

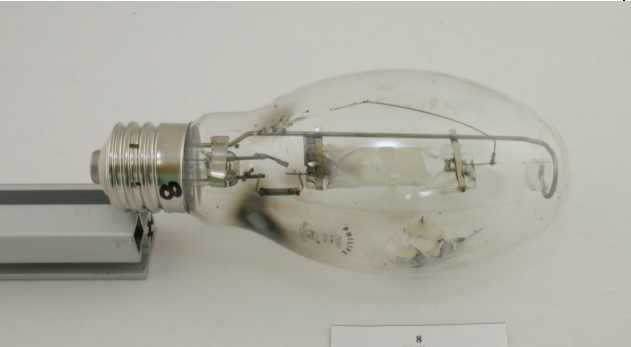
<p data-bbox="224 745 766 777">Lamp 8 (non-protected): arc tube ruptured</p>

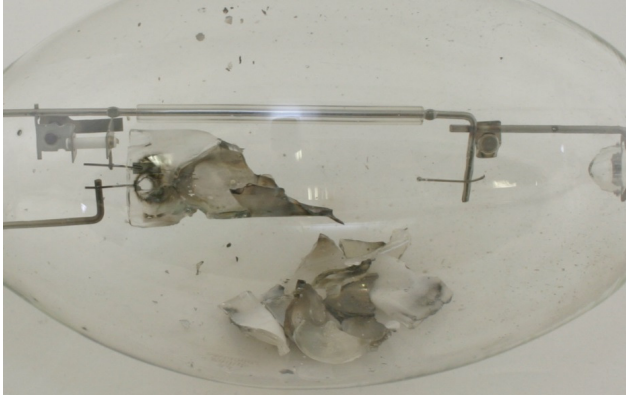
<p data-bbox="212 701 773 737">Lamp 14 (non-protected): arc tube ruptured</p>

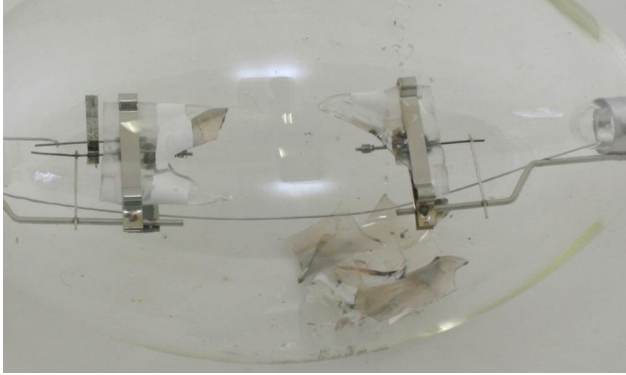
<p data-bbox="212 1134 773 1169">Lamp 15 (non-protected): arc tube ruptured</p>

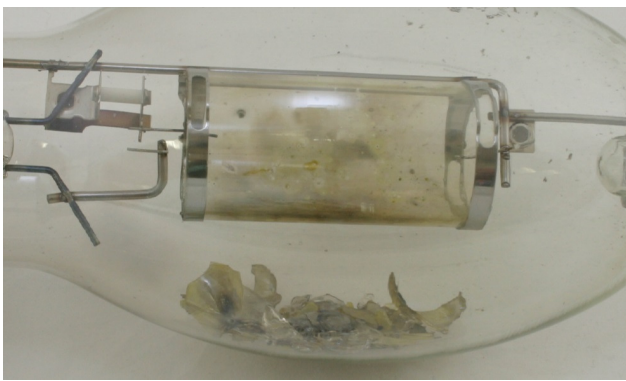
<p>A close-up view of the lamp's interior, showing the broken filament and the surrounding metal cage structure.</p>
<p data-bbox="250 659 735 695">Lamp 5 (protected): arc tube ruptured</p>

<p>A photograph of a clear glass lamp with a metal base. The internal arc tube is visible and appears ruptured, with yellowish debris inside. A small white label with the number '5' is at the bottom.</p>

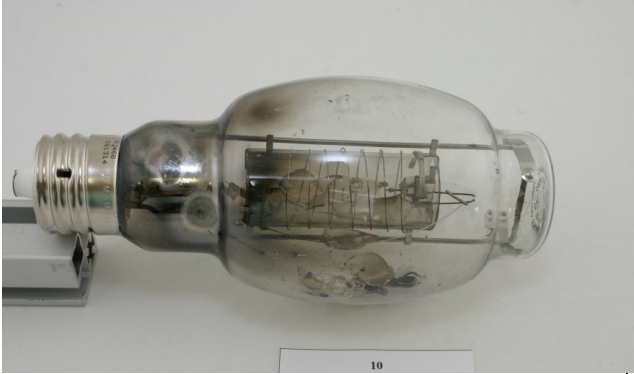
Lamp photo and failure mechanism	Lamp close-up
<p data-bbox="240 260 743 296">Lamp 10 (protected): arc tube ruptured</p>

<p>A photograph of a failed lamp. The glass bulb is dark and contains a metal cage. The arc tube is visible inside, showing signs of rupture. A small label with the number '10' is at the bottom.</p>

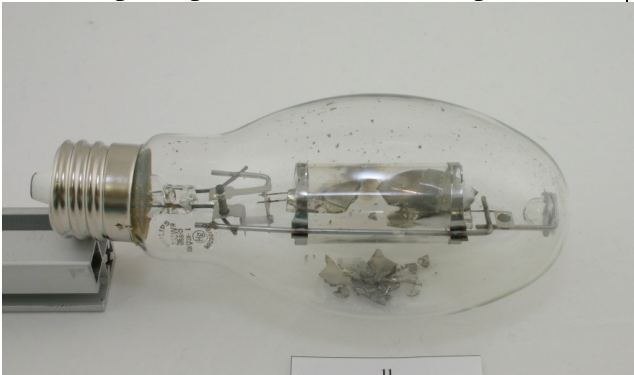
<p>A close-up view of the lamp's interior, showing the metal cage and the damaged arc tube. The glass is dark and shows signs of rupture.</p>
<p data-bbox="240 686 743 722">Lamp 11 (protected): arc tube ruptured</p>

<p>A photograph of a failed lamp. The glass bulb is dark and contains a metal cage. The arc tube is visible inside, showing signs of rupture. A small label with the number '11' is at the bottom.</p>

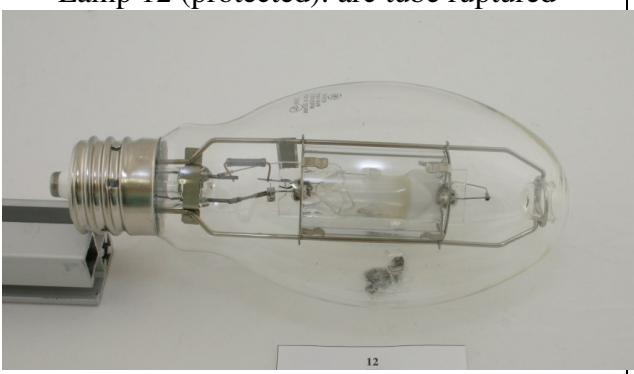
<p data-bbox="240 1113 743 1148">Lamp 12 (protected): arc tube ruptured</p>

<p>A photograph of a failed lamp. The glass bulb is dark and contains a metal cage. The arc tube is visible inside, showing signs of rupture. A small label with the number '12' is at the bottom.</p>

Table 3 documents the failure mode for each of the tested lamp samples. The key at the bottom of the table describes each event. Table 4 and Table 5 list the maximum current and pulse energy (explosion energy) measured for each lamp. There is no current or energy data for lamp 12, as the oscilloscope did not measure the arc tube rupturing event.

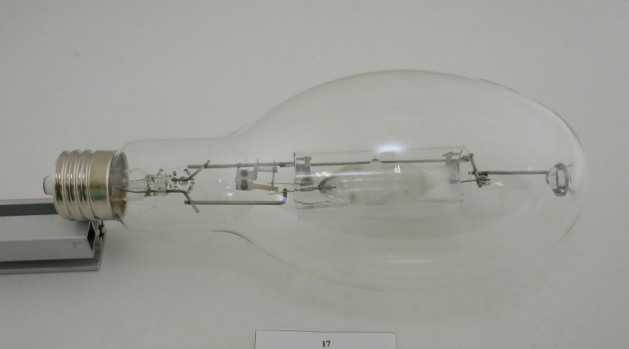
<p>A close-up photograph of the internal components of Lamp 16, showing a broken filament or electrode assembly within the glass envelope.</p>
<p data-bbox="272 678 719 720">Lamp 17 (protected): lamp flashed</p>

<p>A photograph of a clear glass HID lamp with a metal base, showing a broken internal element. A small white label with the number '17' is visible at the bottom center.</p>
